Assessment of Microbiologically Influenced Corrosion Potential in the *International Space Station* Internal Active Thermal Control System Heat Exchanger Materials: A 6-Mo Study

Monsi C. Roman
NASA Marshall Space Flight Center, Huntsville, Alabama, USA

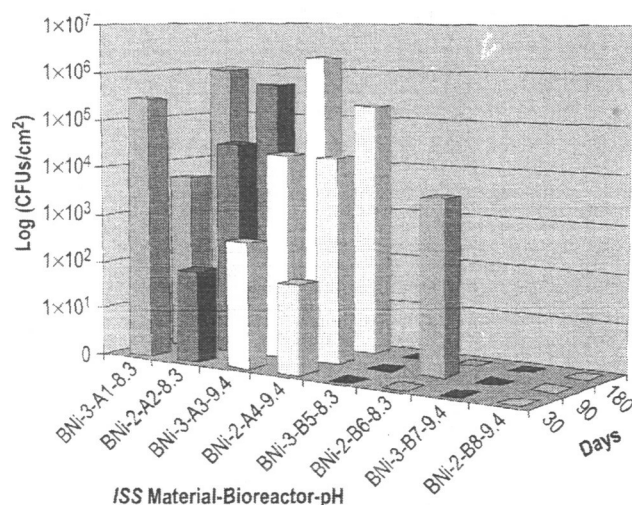
Figure 3. Colonization of *ISS* Heat Exchanger Materials

Biofilm Coupon Swab Viable Culture - Figure 3 illustrates the MAT biofilm coupon viable counts at 30-, 90-, and 180-d exposure testing. The data indicate that the coupon materials were colonized at increasing levels over time. Although no attached bacteria were found on the surface of control coupons in bioreactor B6, the bacterial concentration in the fluid of that bioreactor remained constant after it became contaminated.

Except for the 30-d biofilm viable count from the coupon of bioreactor A1, there was no significant difference in colonization levels between the different ISS heat exchanger materials under the different test conditions at each time point. The significantly higher viable count from the 30-d bioreactor A1 coupon sample could be attributed to sampling error associated with the presence of biofilm slime—evident in the flow cell, and sample evidence of yellow slime formation on interior surfaces at all time points.

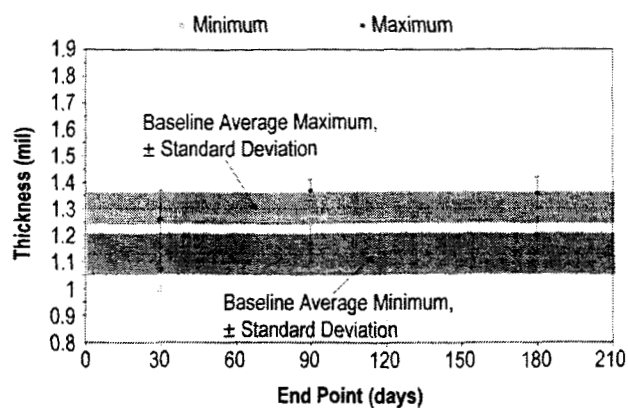
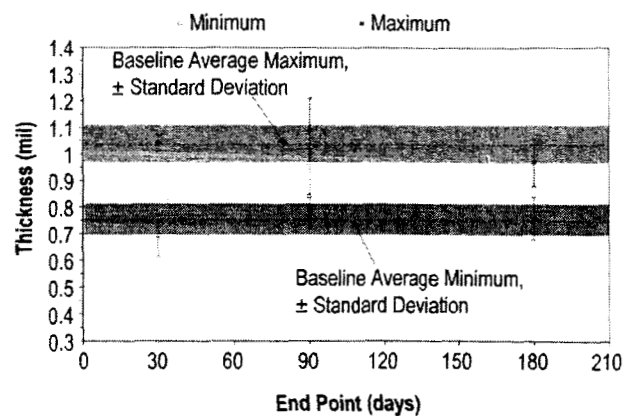
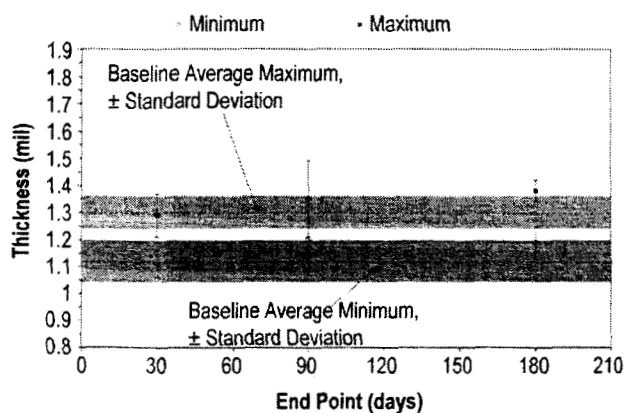
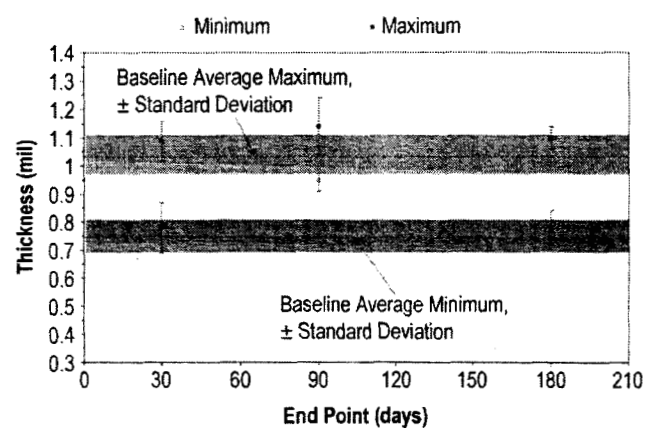
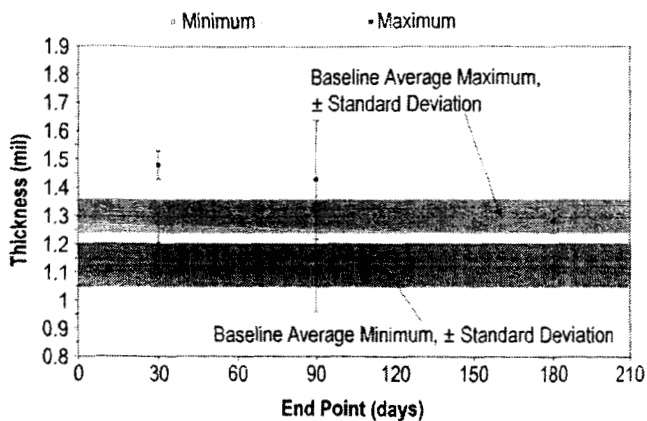
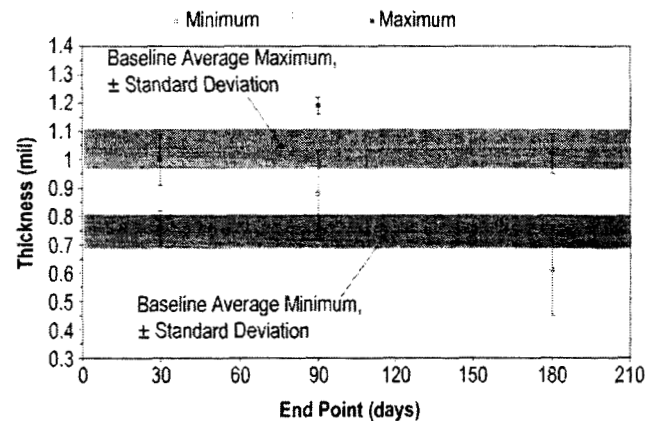
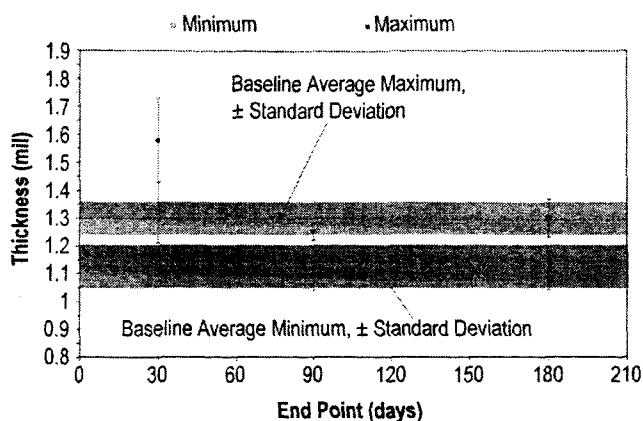
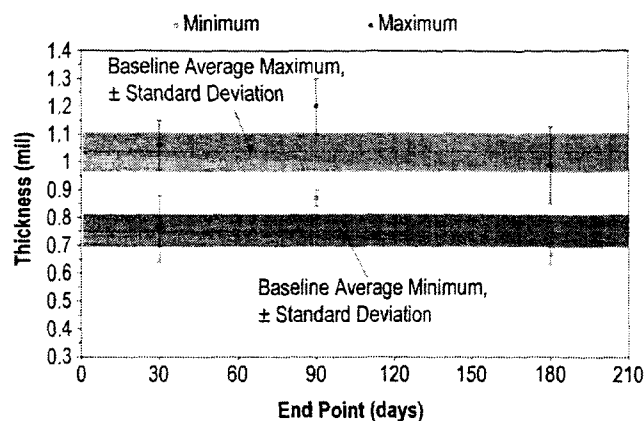
Optical Microscopy of Cross-Sectioned Samples - Figures 4–11 show the average minimum and maximum braze thickness values and associated standard deviation for the approximately evenly spaced locations of the unexposed and end point samples. To facilitate comparison, each sample type is plotted on identical y axes, and the thickness is plotted over the same range (1.1 mil) independent of sample type. The averages for the end point samples are represented by either a hollow square (minimum) or a filled square (maximum) and the standard deviation by error bars. The average minimum and maximum thickness of the unexposed samples are represented by horizontal dashed lines. Additionally, a shaded region, with a height of plus/minus the standard deviation of the associated averages, is centered on the baseline average values. The error bars and shaded regions then provide a measure of the scatter associated with the minimum and maximum values, and the distance between the maximum and minimum a measure of the samples' roughness. Graphing both the unexposed and end point data in this manner allows for comparison of the unexposed and end point samples and of inoculated versus uninoculated effects.

Graphical Analysis - In this analysis of the braze thickness data, a significant difference was said to exist when an end point sample's maximum or minimum value did not graphically fall within the corresponding maximum or minimum shaded region of the unexposed samples. The end point sample was defined as the entire range represented by the error bars. As none of the samples showed the formation of corrosion products on their surfaces, end point samples whose thickness values were above the corresponding shaded region were considered not to have experienced corrosion-related damage. However, samples whose end point values fell below their corresponding unexposed shaded region were considered to be candidates that may have experienced corrosion-related damage. Reviewing figures 4–11 with this criterion in mind, none of the samples showed corrosion-related damage. There are two 180-d samples whose minimum values almost do not meet this criterion; namely, samples 362—exposed to pH 9.4 and inoculated conditions, and 374—exposed to pH 9.4 and uninoculated conditions. However, the

As shown above, the criteria used in the graphical analysis sets the detection limit for corrosion-related damage. Consider sample 374 for example. For the BNi-3 samples, the standard deviation of the minimum thickness of the unexposed samples was 0.06 mil and the standard deviation of sample 374's minimum thickness was 0.04 mil. Therefore, for this sample, the detection limit was 0.1 mil.

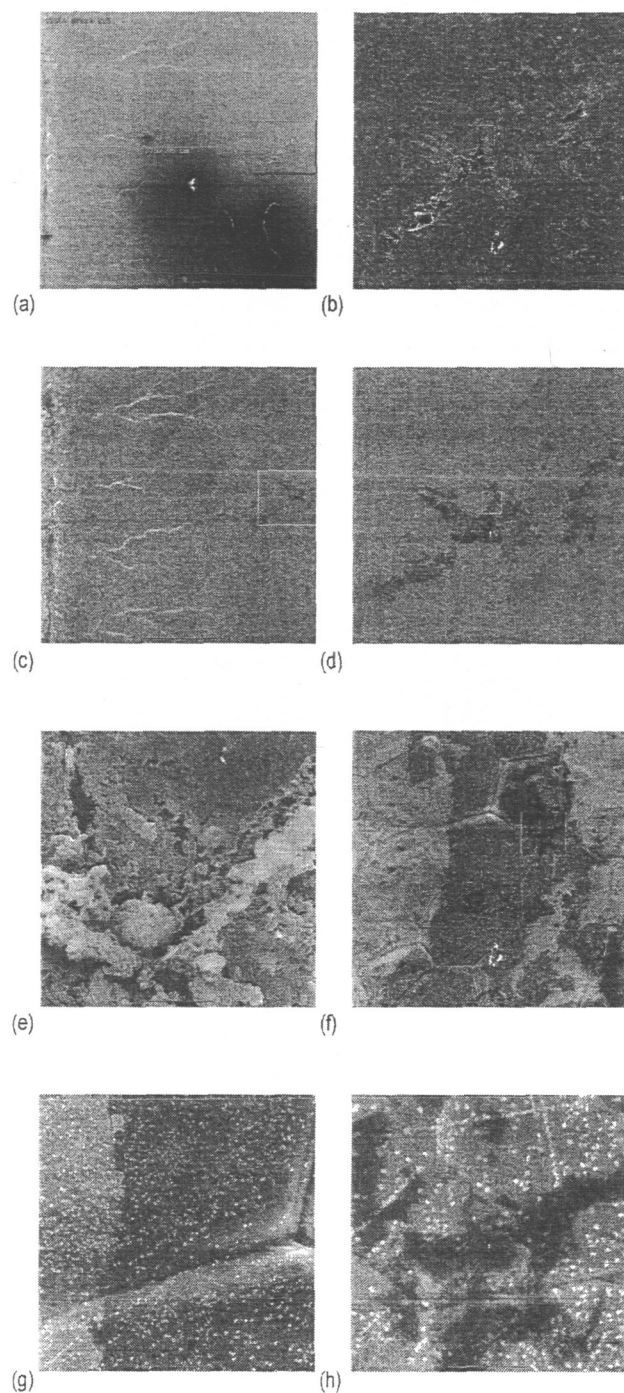
Under Biofilm Corrosion Evaluation - Figure 12 illustrates the results of biofilm removal from the surface of BNi-2 sample 215 for examination of the condition of the underlying brazing. The position of the targeted microcolony on the coupon was mapped using SEM at low magnification. Vein-like features extending out from the fillet of the sample served as landmarks for locating the microcolony after cleaning of the coupon. The result of the cleaning was that the microcolony was removed, along with its gold coating, leaving a footprint of the area it had once covered. The footprint resulted from the contrast between the areas underneath the microcolony that were exposed (dark color) from cleaning and the areas outside of the microcolony that remained coated with gold after cleaning (light color).

Figure 12(e) shows the characteristics of the microcolony. The microcolony was heterogeneous in its distribution and thickness of microbial cells. Likewise, figure 12(f) shows the area depicted in figure 12(e) with approximately $\times 4$ less magnification after cleaning. The contrast between the gold-coated areas and the areas cleaned of biofilm are apparent. The brazing of the coupon underneath where the microcolony was removed showed no damage. Figures 12(g) and 12(h) show the areas depicted by the arrow and square, respectively, in figure 12(f). These figures do not show evidence of corrosion attack of the brazing grains or grain boundaries underneath the microcolony. Additionally, no attack in the immediate vicinity of the microcolony was observed.

Direct examination of the surface underneath and in the vicinity of an ≈1-mm^2 microbial colony on a BNi-2 coupon sample showed no evidence of corrosion associated with this microbial colony. There was no indication that the formed biofilm in that area affected the surface of the material after 6 mo of exposure. This was only one data point (one microcolony) and analyses of additional microcolonies are needed to verify this finding.

No significant corrosion damage, and specifically no MIC, was identified in this study. In an effort to understand if MIC/corrosion is or will be an issue in the *ISS* IATCS, it is recommended that the exposure period be increased in future testing. The analyses of IATCS flight hardware will ultimately help validate the results of this test.
